Inspection Report

1234 Great View
Somewhere IL 61533

Greater Peoria Property Inspections

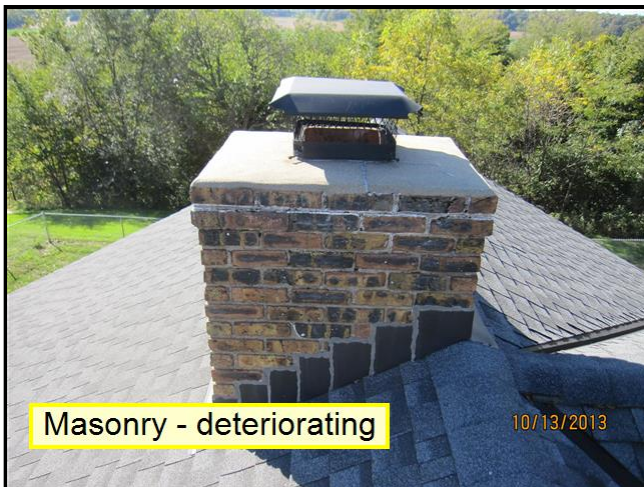
1.3 Item 1(Picture)

1.3 Maintenance - The grout on the brick chimney is deteriorating and needs maintenance. A qualified masonry contractor should tuck point the deteriorated areas.

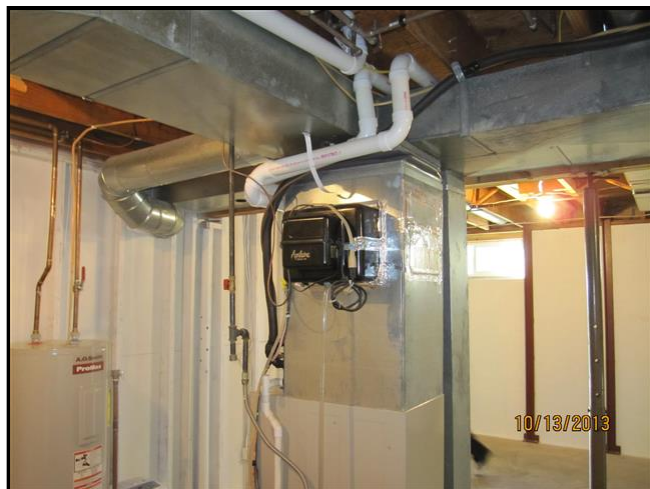
5.0 Item 1(Picture)

5.0 The furnace had a humidifier attached. Humidifiers are designed to raise relative humidity levels in homes located in dry climates by adding moisture vapor to air heated by the furnace. Because a warm moist environment such as that which exists in humidifiers can promote the growth of bacteria, yeasts, and molds, the housing, condensation tubes and pumps must be kept clean. In accordance with the Standards of Practice the Inspector does not evaluate humidifiers. You should ask the seller about the functionality of the humidifier. Many homeowners do not understand the maintenance requirements connected with these appliances and the Inspector recommends that you contact the humidifier manufacturer to ask about any maintenance requirements.

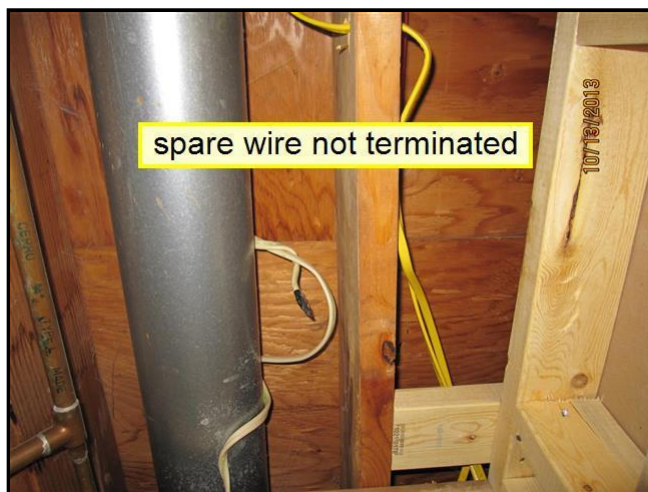
6.3 Item 1(Picture)

6.3 (2) A spare wire in the ceiling of the water softener closet was not terminated properly. I recommend this be terminated in a junction box or removed.

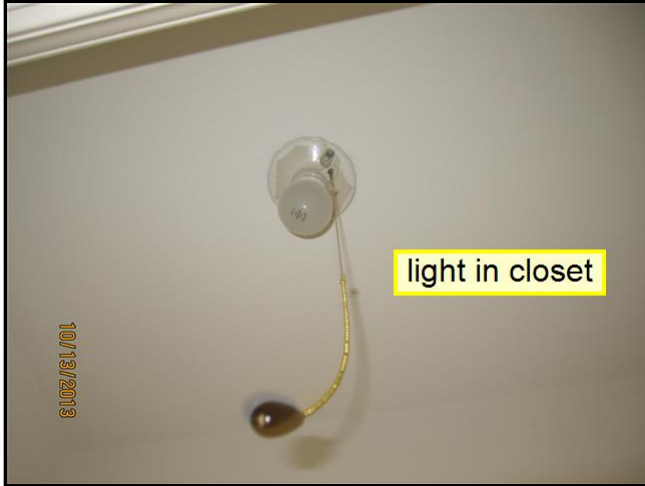
6.4 Item 1(Picture)

6.4 Safety - Due to risk of fire, the International Building Code and the National Electrical Code require that all fixtures installed in closets must be either surface-mounted or recessed and must completely enclose the bulb. Only incandescent or fluorescent lamps are allowed.

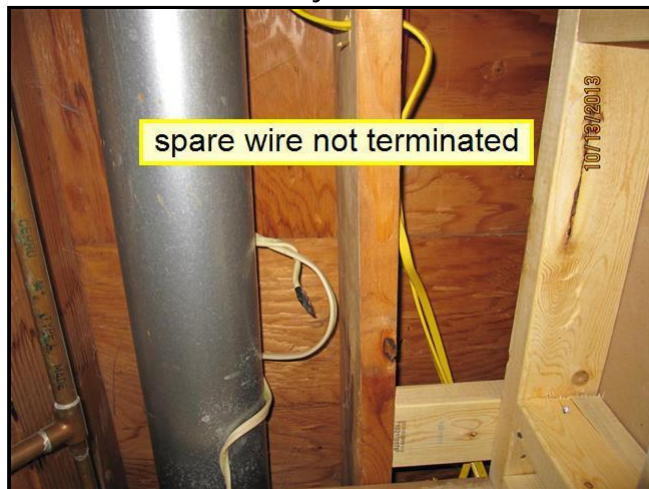
6.3

(2) A spare wire in the ceiling of the water softener closet was not terminated properly. I recommend this be terminated in a junction box or removed.
